2. Drive start

To read and write data, a HDD has to pass successfully the startup procedure that consists of several initialization stages (the subdivision is conventional, based on data recovery experience of the utility developers):

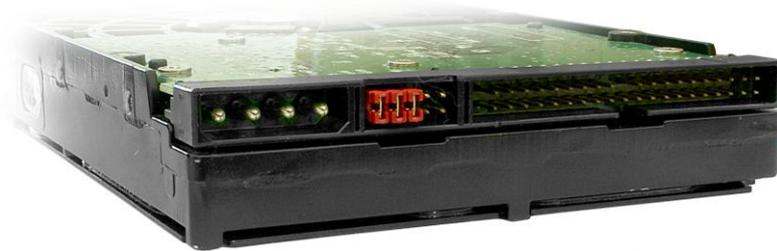
Fig. 2.6.

Board damage may prevent it from reaching readiness. In that case you may use the Kernel (Safe) mode jumpers. Kernel (Safe) mode can be enabled for 3.5" IDE (PATA) WD Caviar & Marvell HDD by setting three jumpers at the same time: CS, SLAVE, and MASTER (*Figure 2.6*). The spindle motor in that case does not spin up and the drive switches to a special mode (PSV Mode), which allows ROM reading/writing, editing of the heads map and other operations.

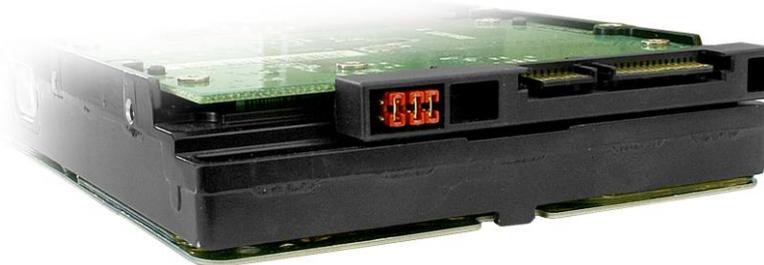
Fig. 2.7.

For 3.5" SATA WD HDD you will also have to set three jumpers, but their positions will be different: PM2, OPT1, and OPT2 (*Figure 2.7*). For WD Marvell-ROYL HDD the same three jumpers must be set, though one of them is named differently: PM2, OPT1, and FW.

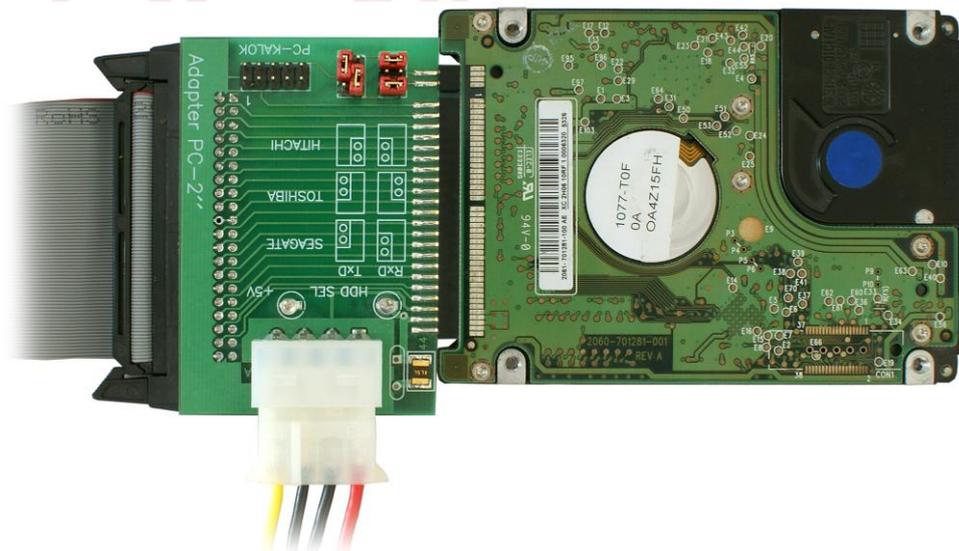
Fig. 2.8.

To enable Kernel (Safe) mode for 2.5" WD HDD, you have to set the jumpers on the PC-2" adapter (*Figure 2.8*).

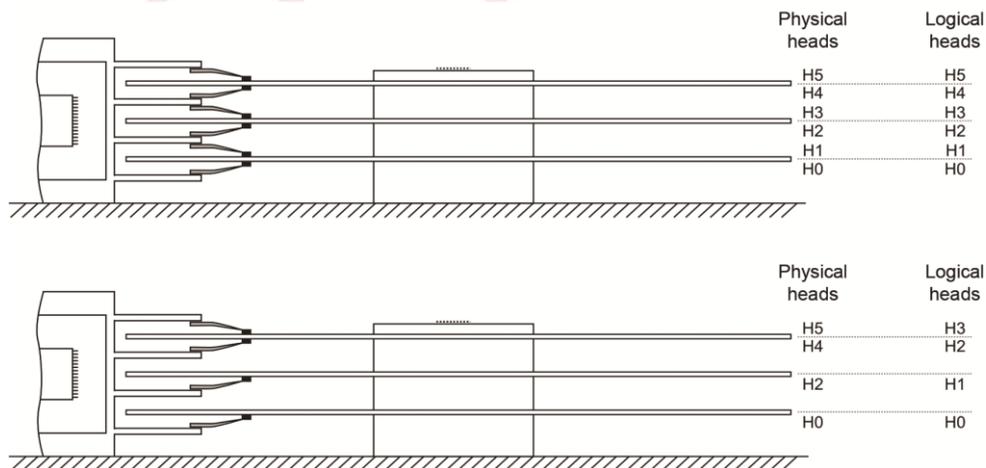
Fig. 2.10. Physical and logical heads numbering.

«Heads configuration» switch determines the heads map source. When the setting «From map» is selected, the utility reads the numbers of physical heads from the bit map byte in ROM (located in module ID=0Ah), while the «Default» parameter makes the utility identify the active physical heads by actual presence of connected heads. Please note, that the «Default» mode does not allow reading the map produced after the polling of existing heads (generally, you can view the generated map in RAM, but in this case the feature searching RAM for the map will find nothing).

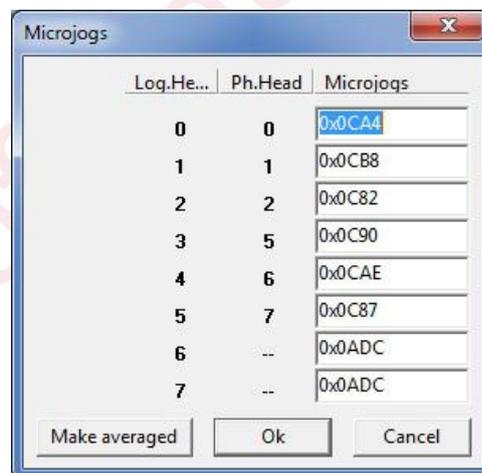
Fig. 2.17.

The dialog (Fig. 2.17) contains the MicroJog values in hexadecimal notation for each logical head³ (see the footnote on page 21). Our experience tells that a discrepancy of 300 can already be too high so you have to choose a donor having as close values as possible. To estimate a donor drive fitness for a «HOT SWAP» operation, you should write to it a generated «average» module ID=47h and check whether the HDD starts using that module.

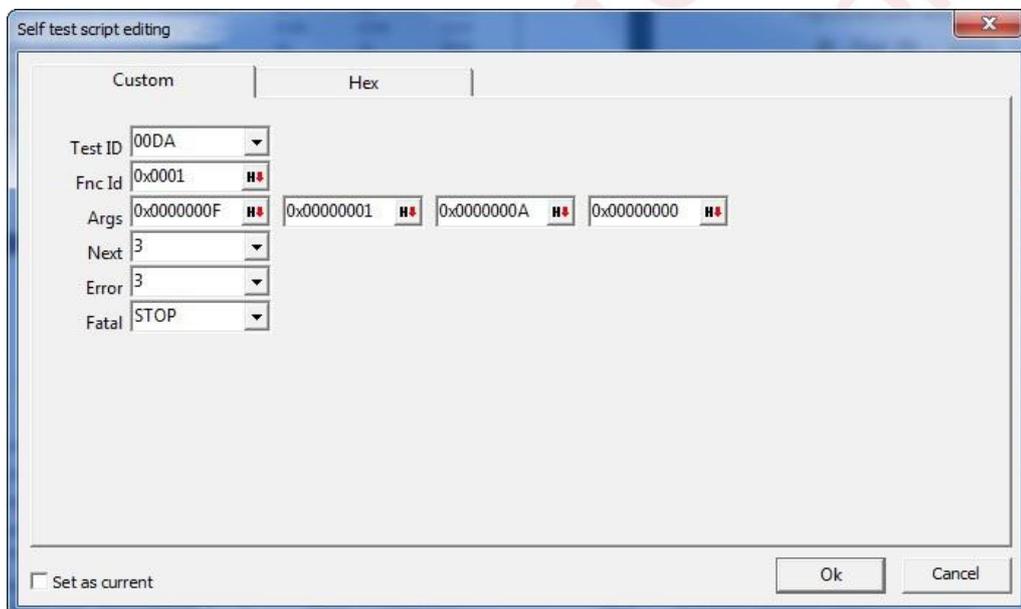
Fig. 4.2.

The test control record consists of the following settings:

- ◆ **Test ID** - test number. It also matches the ID of an appropriate service area module containing the program code for the test.
- ◆ **Fnc Id** - test function number.
- ◆ **Args** - a set of arguments for the test.
- ◆ **Next** - step number where the test should proceed in case of successful completion.
- ◆ **Error** - step number where the test should proceed in case of error.
- ◆ **Fatal** - step number where the test should proceed in case of a fatal error (emergency termination).

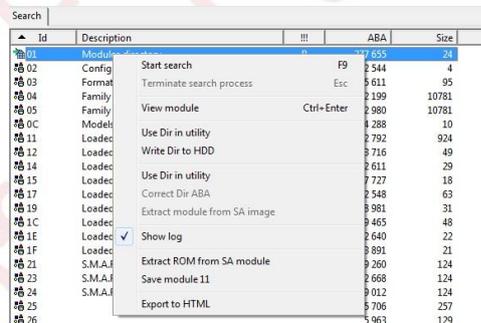
Fig. 5.3. Module search result and the shortcut menu.

In the displayed settings window, toggle the selection to «Search by CHS». The SA SPT will then be substituted incorrectly because it has not been identified during utility start. To identify SA SPT automatically, click the «...» button. After the search the utility displays the list of found modules. Select one of them and use the shortcut menu to «Save module 11».

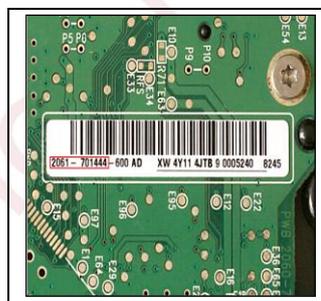
Fig. 6.1. PCB identification number.

What happens when another board with a matching number is installed on a WD drive instead of its native PCB?

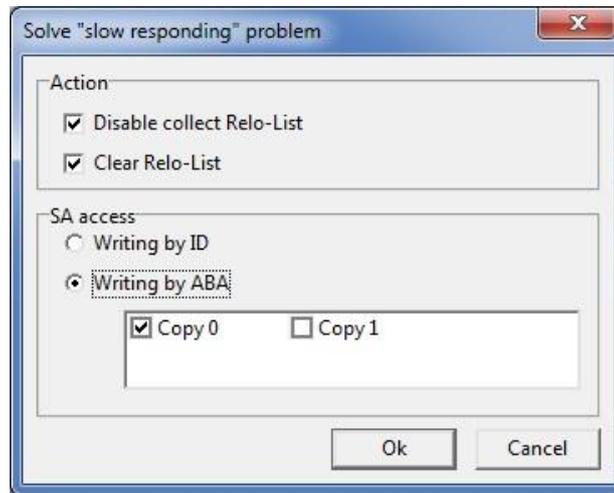
Fig. 8.4. Settings window for the slow response problem solution.

To make SA modification safer you can change just the zero copy, selecting the command to write using ABA and leaving only copy 0 selected. Then, click «OK» and monitor the progress of the procedure via the log.

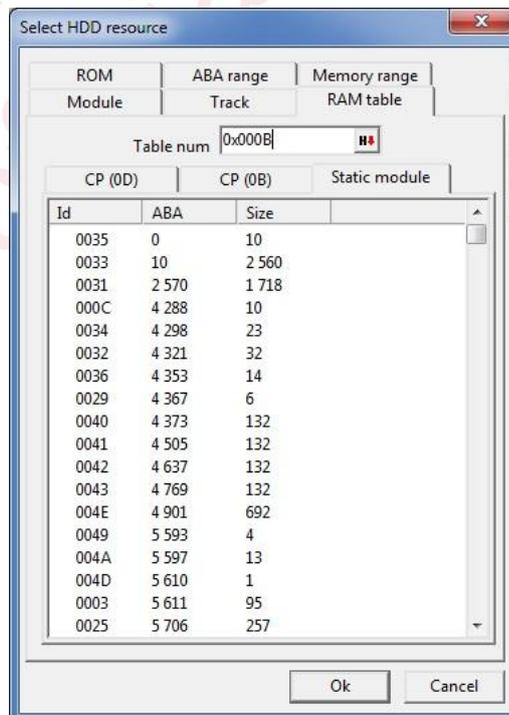
Fig.8.7. ID=0Bh module reading from RAM.

Edit, in RAM, the module containing the map of regions. To do this you have first have to check the utility log generated during utility start to identify the active map module. The message «Flash ROM dir (ext) reading..... : Ok (Active)» means that the active module is ID=20Bh. Otherwise (just the message «Flash ROM dir reading..... : Ok») the active module is ID=0Bh (Fig. 8.7.).
