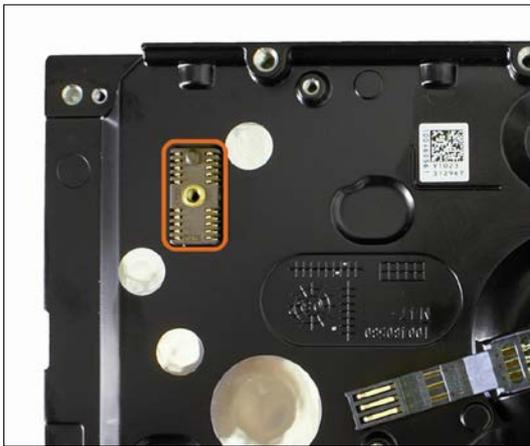
Fig. 5.2

- ◆ non-native controller board;
- ◆ damaged read/write heads in the HDA;
- ◆ broken contact between the controller board and HDA in the connector of the commutator preamplifier (oxidized contacts, etc.) (Fig. 5.2);
- ◆ damaged service information (SMART, G-List, translator...).

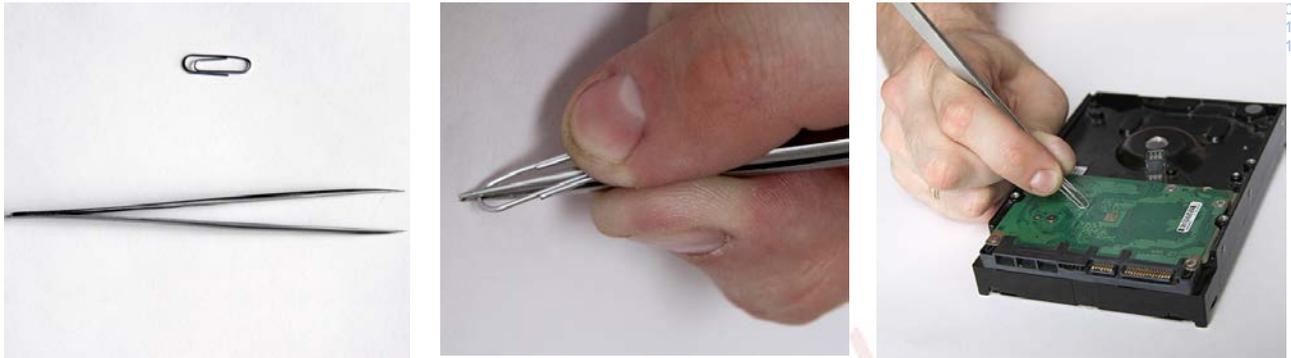
Fig. 8.2

short connection ark size must be minimal. The simplest solution in such situations would be small tweezers with sharp edges holding a metal paper clip (see Fig. 8.2).

If your selected tool complies with the described requirements, short-circuit connection makes the HDD produce knocking sounds and after a while reach the ready state with its motor stopped. You are advised to pick the appropriate tool in advance by bridging the read channel of a functional drive and switching on the HDD power supply.
