Network OS 7.0.1 for Brocade VDX

Release Notes v4.0

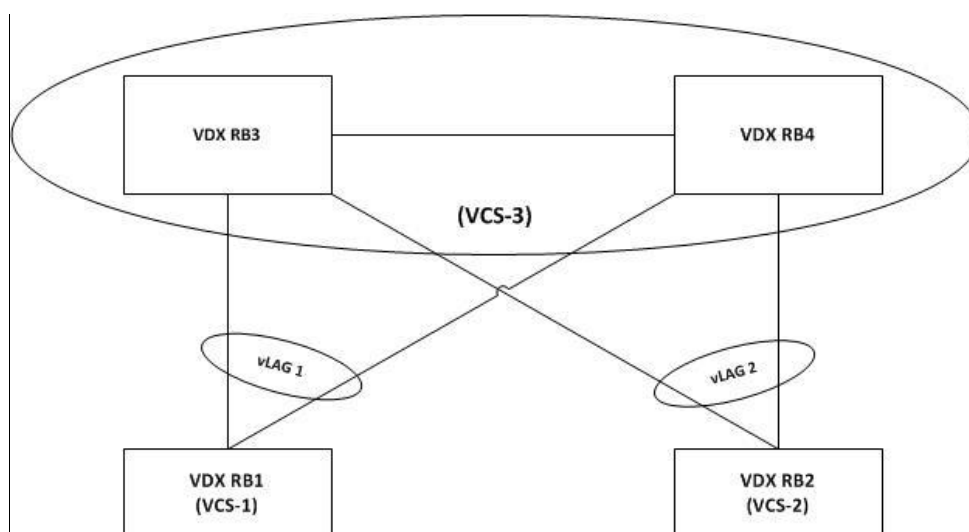
vLAG deployment upgrade Illustration

- **Approach 1:** Graceful shutdown of vLAG ports on one node at a time.
- **Approach 2:** Static vLAGs and Dynamic vLAGs without configuration changes.

Approach 1: Graceful shutdown of vLAG ports on one node at a time.

Step 1: If in FC mode, shut the port-channel associated with vLAG 1 on RB3. With LC mode, shutting down port-channel takes down entire port-channel including port-channel interfaces on remote RBs. Therefore, if in LC mode, shut all the member ports of the vLAG 1 on RB3.
