Extreme Network OS 7.2.0d for Extreme VDX devices Release Notes v3.0

9036239-01 Rev AC

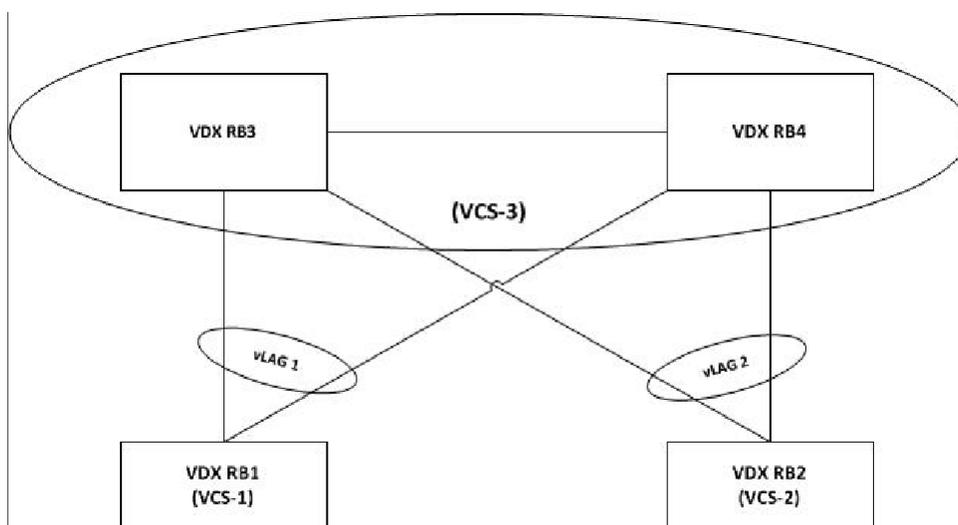
vLAG deployment upgrade Illustration

- **Approach 1:** Graceful shutdown of vLAG ports on one node at a time.
- **Approach 2:** Static vLAGs and Dynamic vLAGs without configuration changes.

Approach 1: Graceful shutdown of vLAG ports on one node at a time.

Step 1: With LC mode, shutting down port-channel takes down entire port-channel including port-channel interfaces on remote RBs. Therefore, if in LC mode, shut all the member ports of the vLAG 1 on RB3.
